Samsung Galaxy Tab 3 8.0 Charging Port Replacement

If the device will not charge despite a power cable and battery replacement, replacing this component is the likely solution.

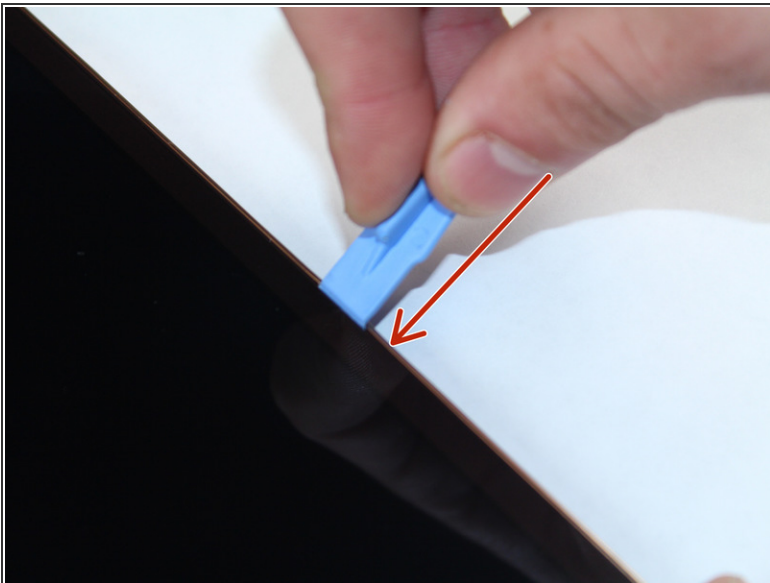
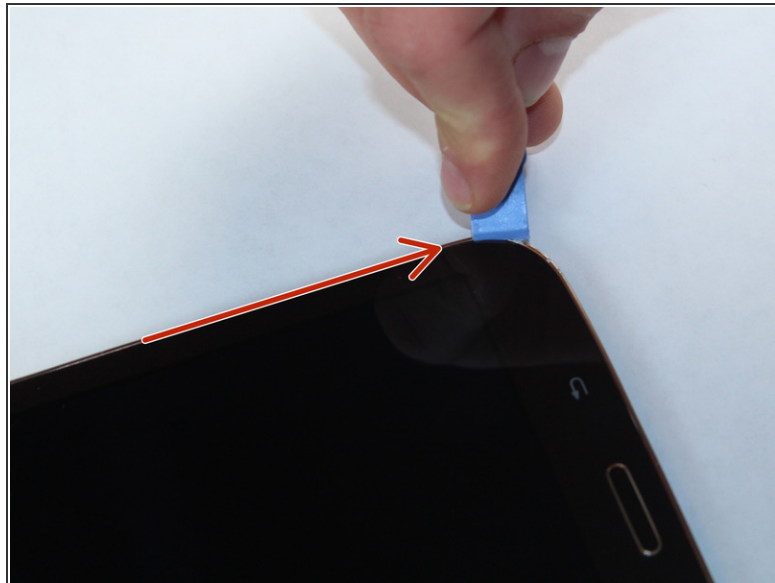
Step 1 — Battery - Open up the tablet

- Start out by separating the screen from the back cover using the larger plastic opening tool to pry them apart.

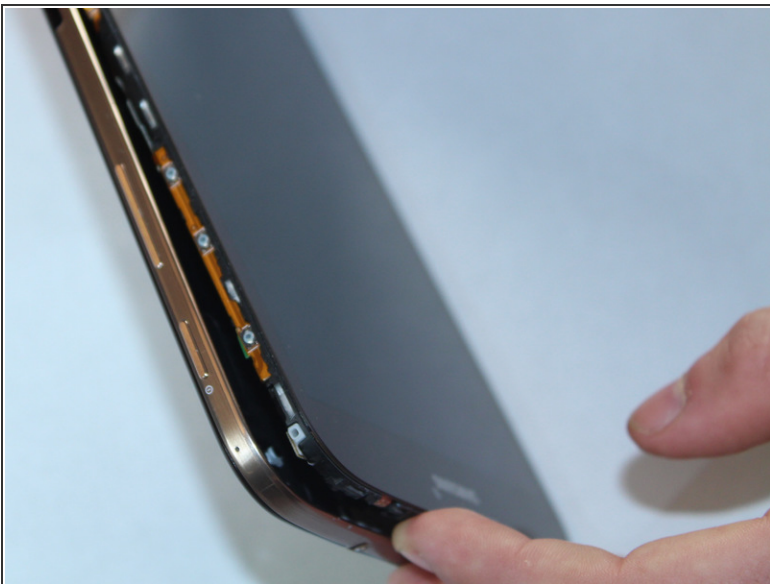
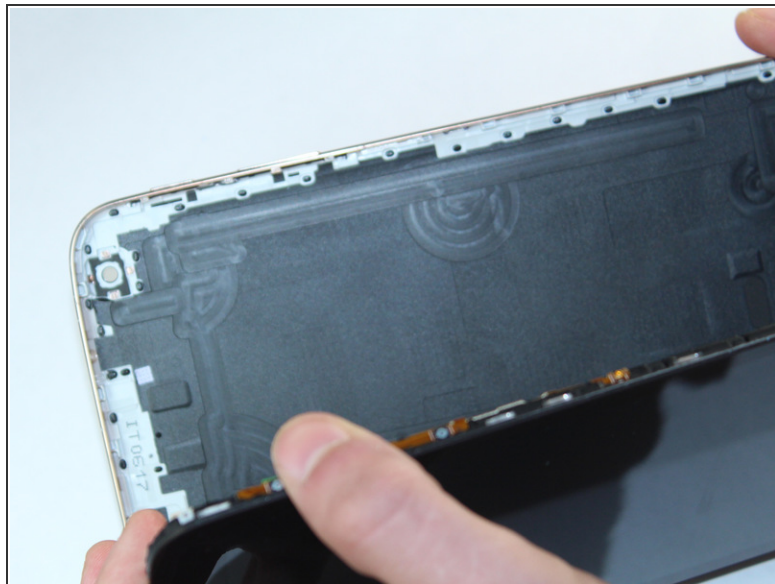
Step 2 — Remove Back Cover

- Once every part of the screen is separated from the back cover, you should be able to fully remove it with your hands.

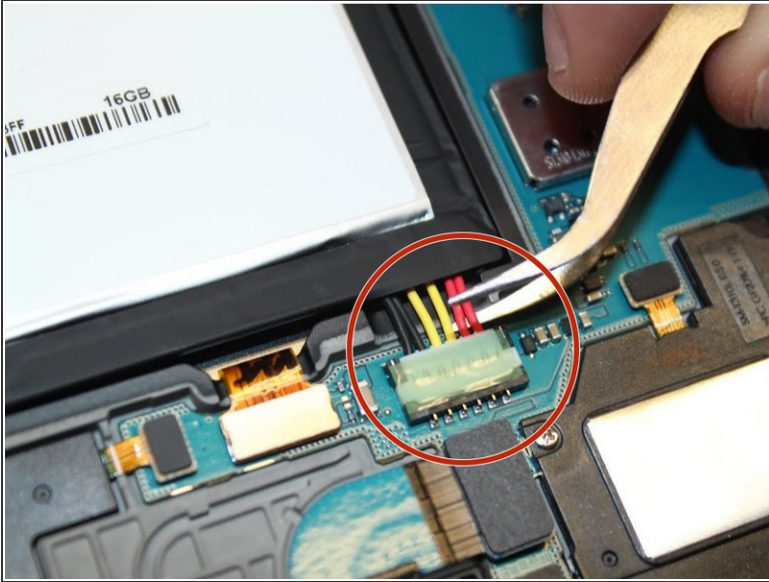
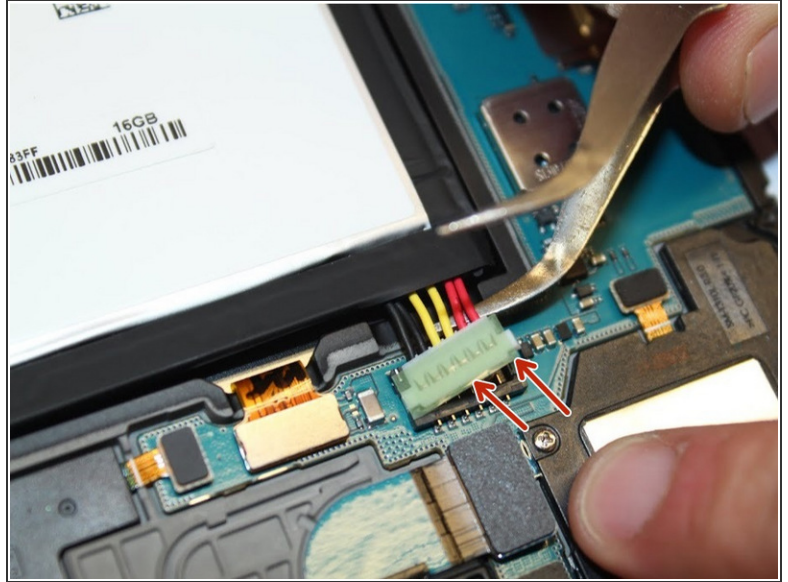
Step 3 — Disconnect Battery

- To remove the battery you must use something small, such as tweezers, to disconnect the battery from its port.

Note: the connection lifts up to remove

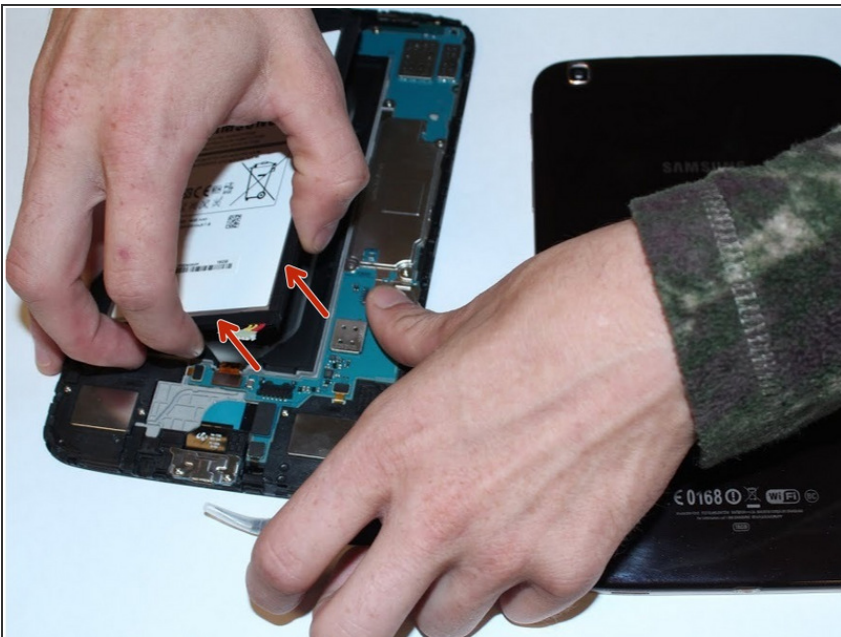
Step 4 — Remove Battery

- After the battery is disconnected you may use your hands to pull out the battery. It may be a little difficult because there is adhesive on the backside of the battery.

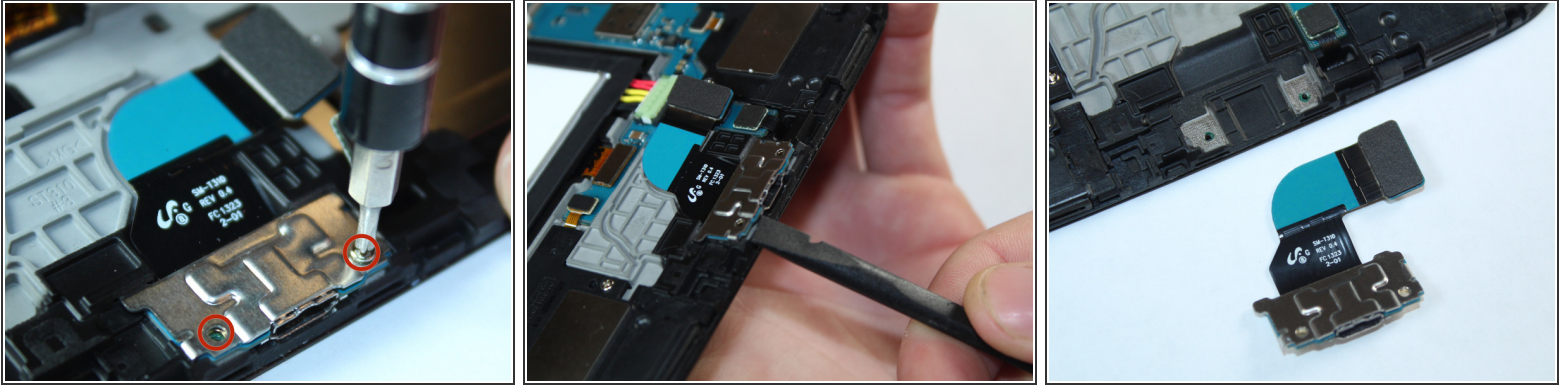
Step 5 — Unscrew Charging Port

- Unscrew the 2.9mm screws from the charging port with Phillips Head #000 and use the spudger to pry it up from under the port to remove component from the device.
